**RCRA SITE SCREENING INSPECTION REPORT**  
**Enforcement Confidential – Deliberative Process**

SITE NAME: Canton Drop Forge  
EPA ID NUMBER: OHD004465142  
ADDRESS: 4575 Southway Street S.W.  
Canton, Ohio 44706  
DATE OF INSPECTION: July 1, 2011  
EPA INSPECTOR: Michael Beedle

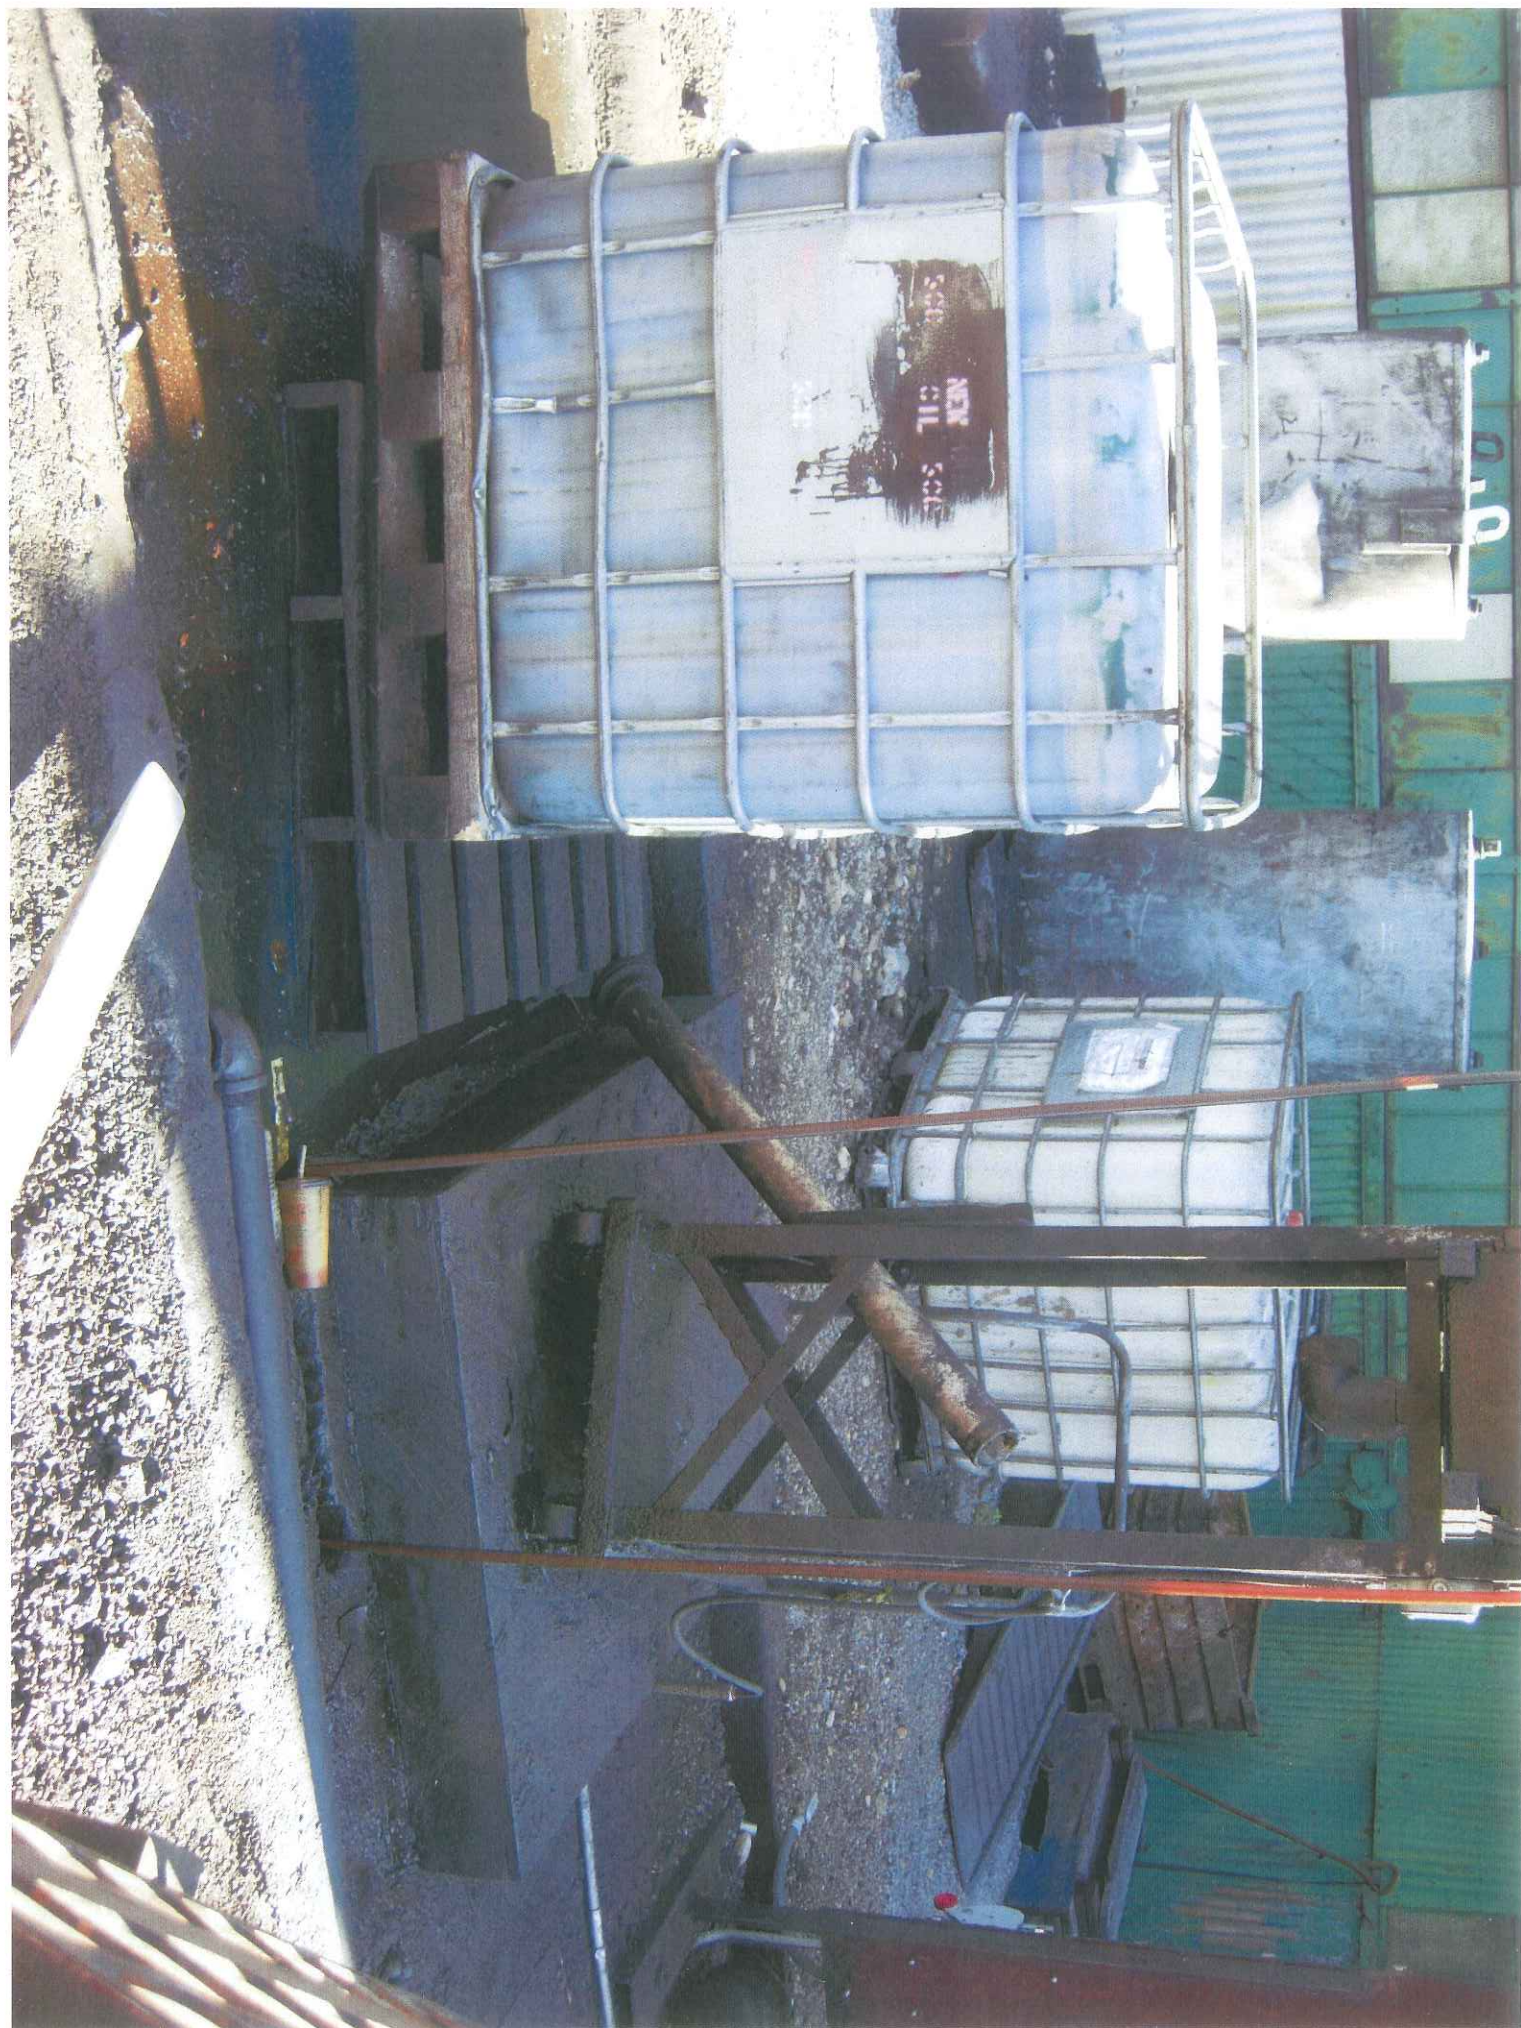
Canton Drop Forge Photo 01, by Mike Beedle ,2011/07/01 07:22:55

We started the tour walking to Pond 1. Photograph 1 is of sump and skimming operations before Pond 1. It is believed that the sump is prior to the plant water being discharge to Pond 1. We continued to Pond 1. I observed flagging and netting on the pond. The whole surface of the pond was covered in black oil. The banks were stained by oil. Mr. Houseknect said the netting and flags were put above the pond to prevent geese landing on it. He said the flags were put on in the spring (2011) and the netting in the fall (2010). He said the netting has to be replaced occasionally. I took photographs of Pond 1 (photographs 2-5). Pond 1 is pumped to Pond 2. Photograph 6 is the pump used for the transfer. The pump did not appear to be running at the time of the inspection.

| Photo | Description |
|---|--|
| 1 | Sump with skimmer prior to Pond 1. Tote on pallet. |

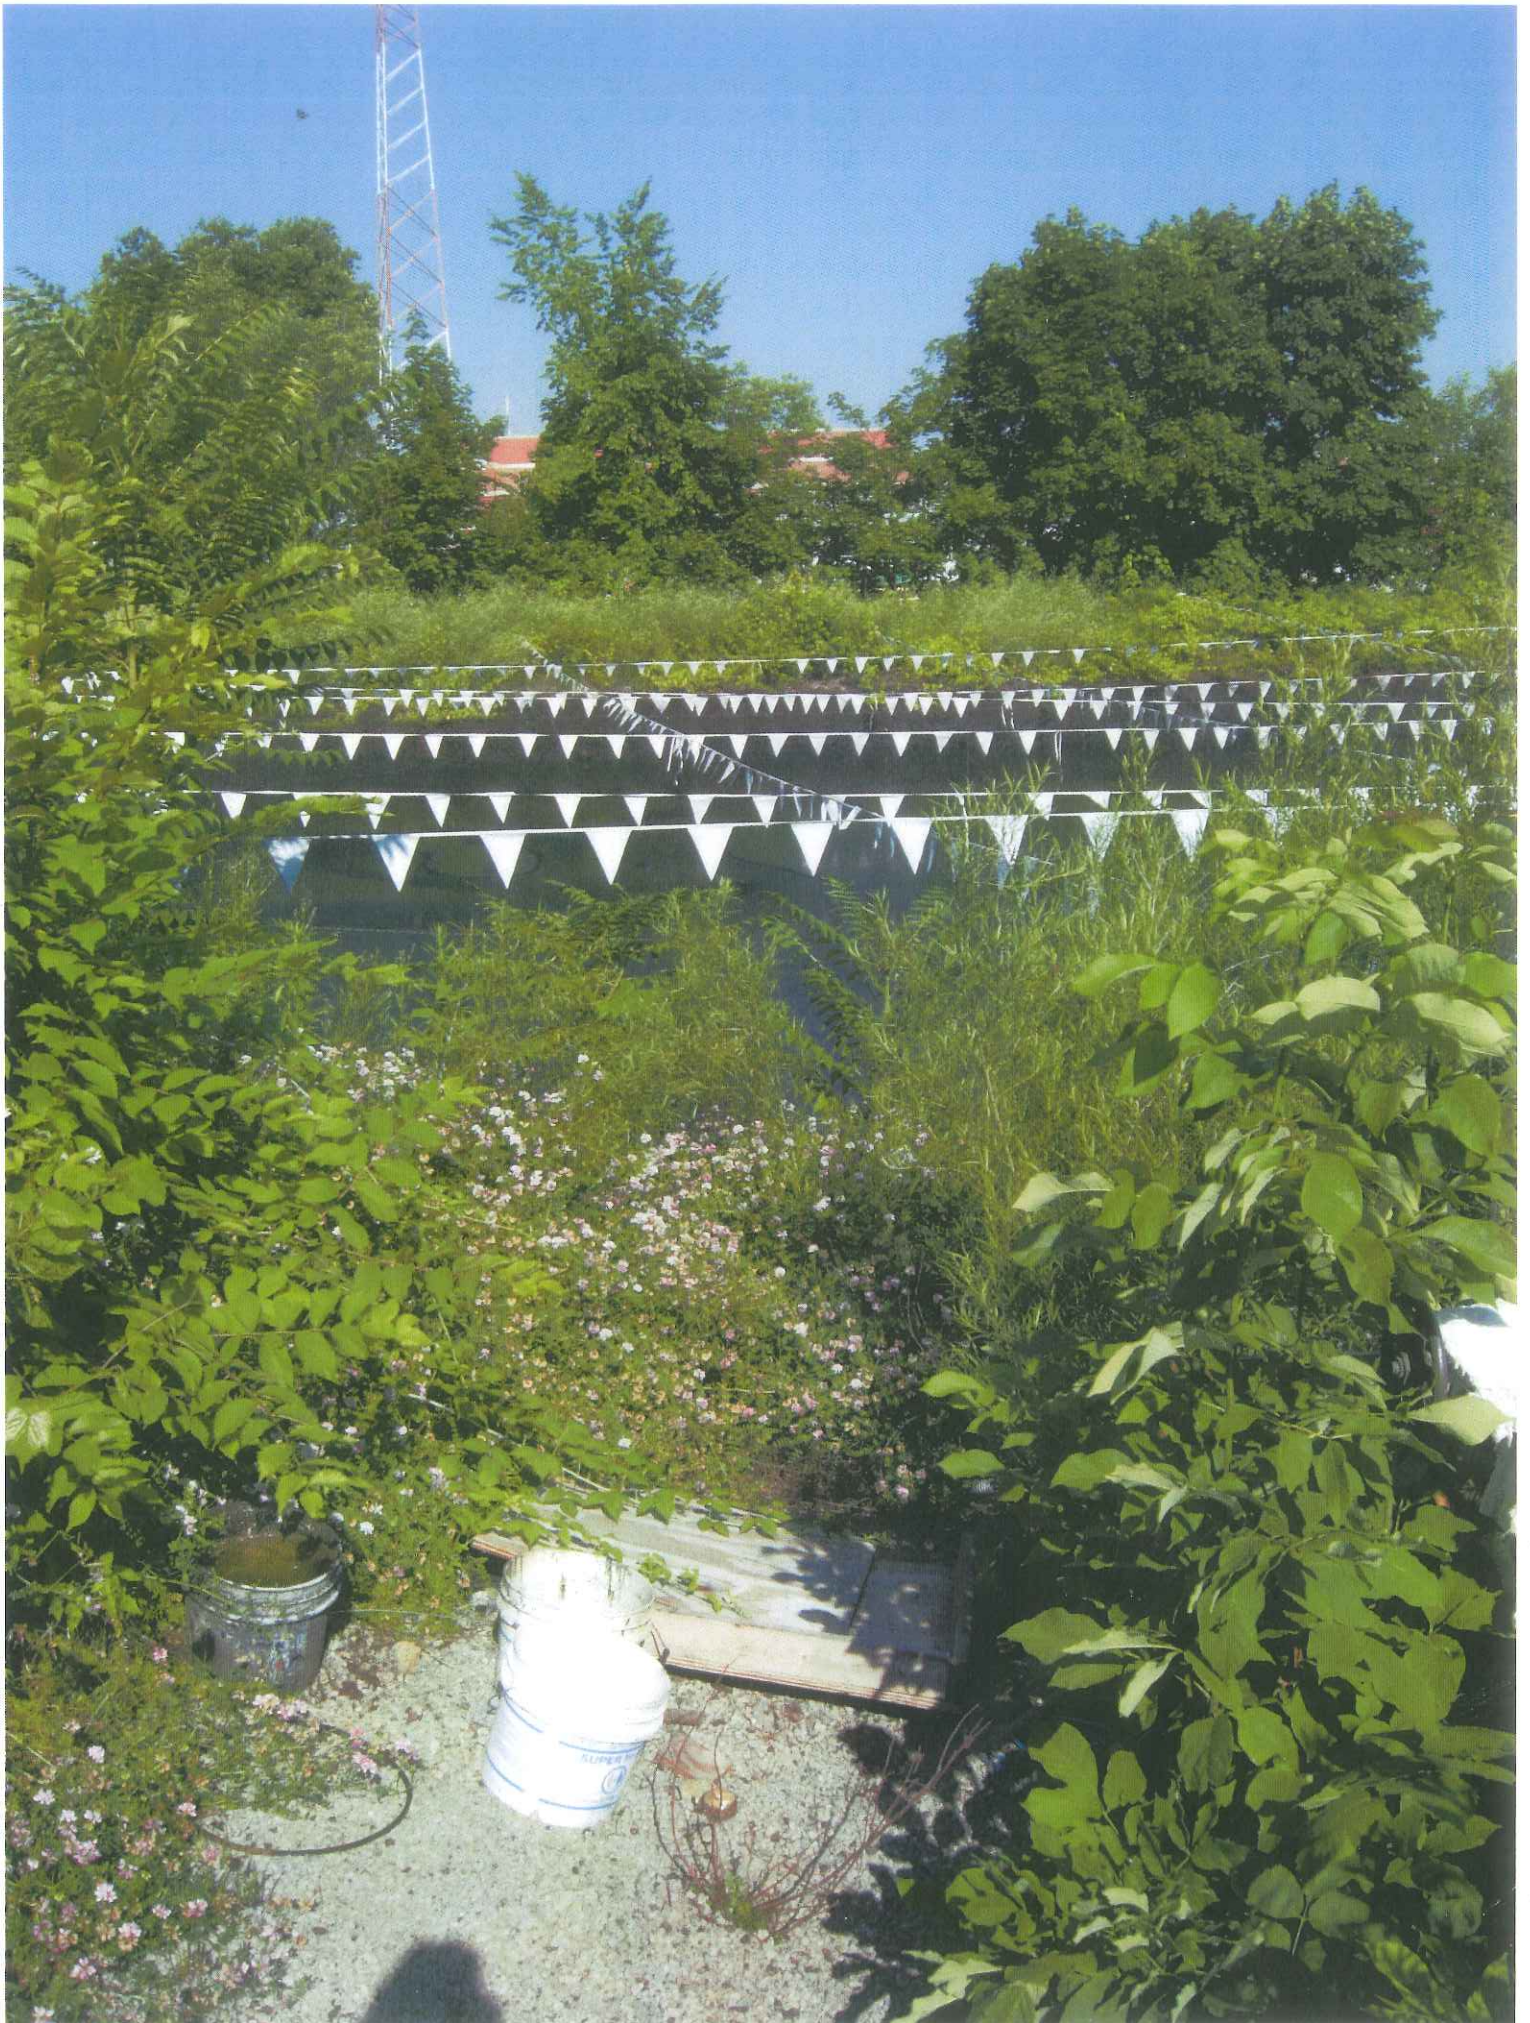
Canton Drop Forge Photo 02, by Mike Beedle ,2011/07/01 07:24:58

| Photo | Description |
|---|--|
| 2 | Pond 1. Southwest side of facility. Oil over the entire surface of the pond. Netting and flags over pond to keep geese from landing. Heavily vegetated area. Taken from the east side of the pond facing west. |

A used oil managed in surface impoundment prohibition case should be developed for this site. A full Compliance Evaluation Inspection (CEI) is recommended for the site. Alternatively information requests can be used to develop a case related to Pond 1 and Pond 2 used oil management. The advantages of a CEI are that a full review of plant operations and oil use can be done. All of the potential used oil drums and tanks can be observed and determined if they were managing used oil. Further the depth of used oil in the impoundments could be potentially determined. Disadvantages of a CEI include the cost of travel and equipment needed to fully evaluate the site and an increase of time to do the work.

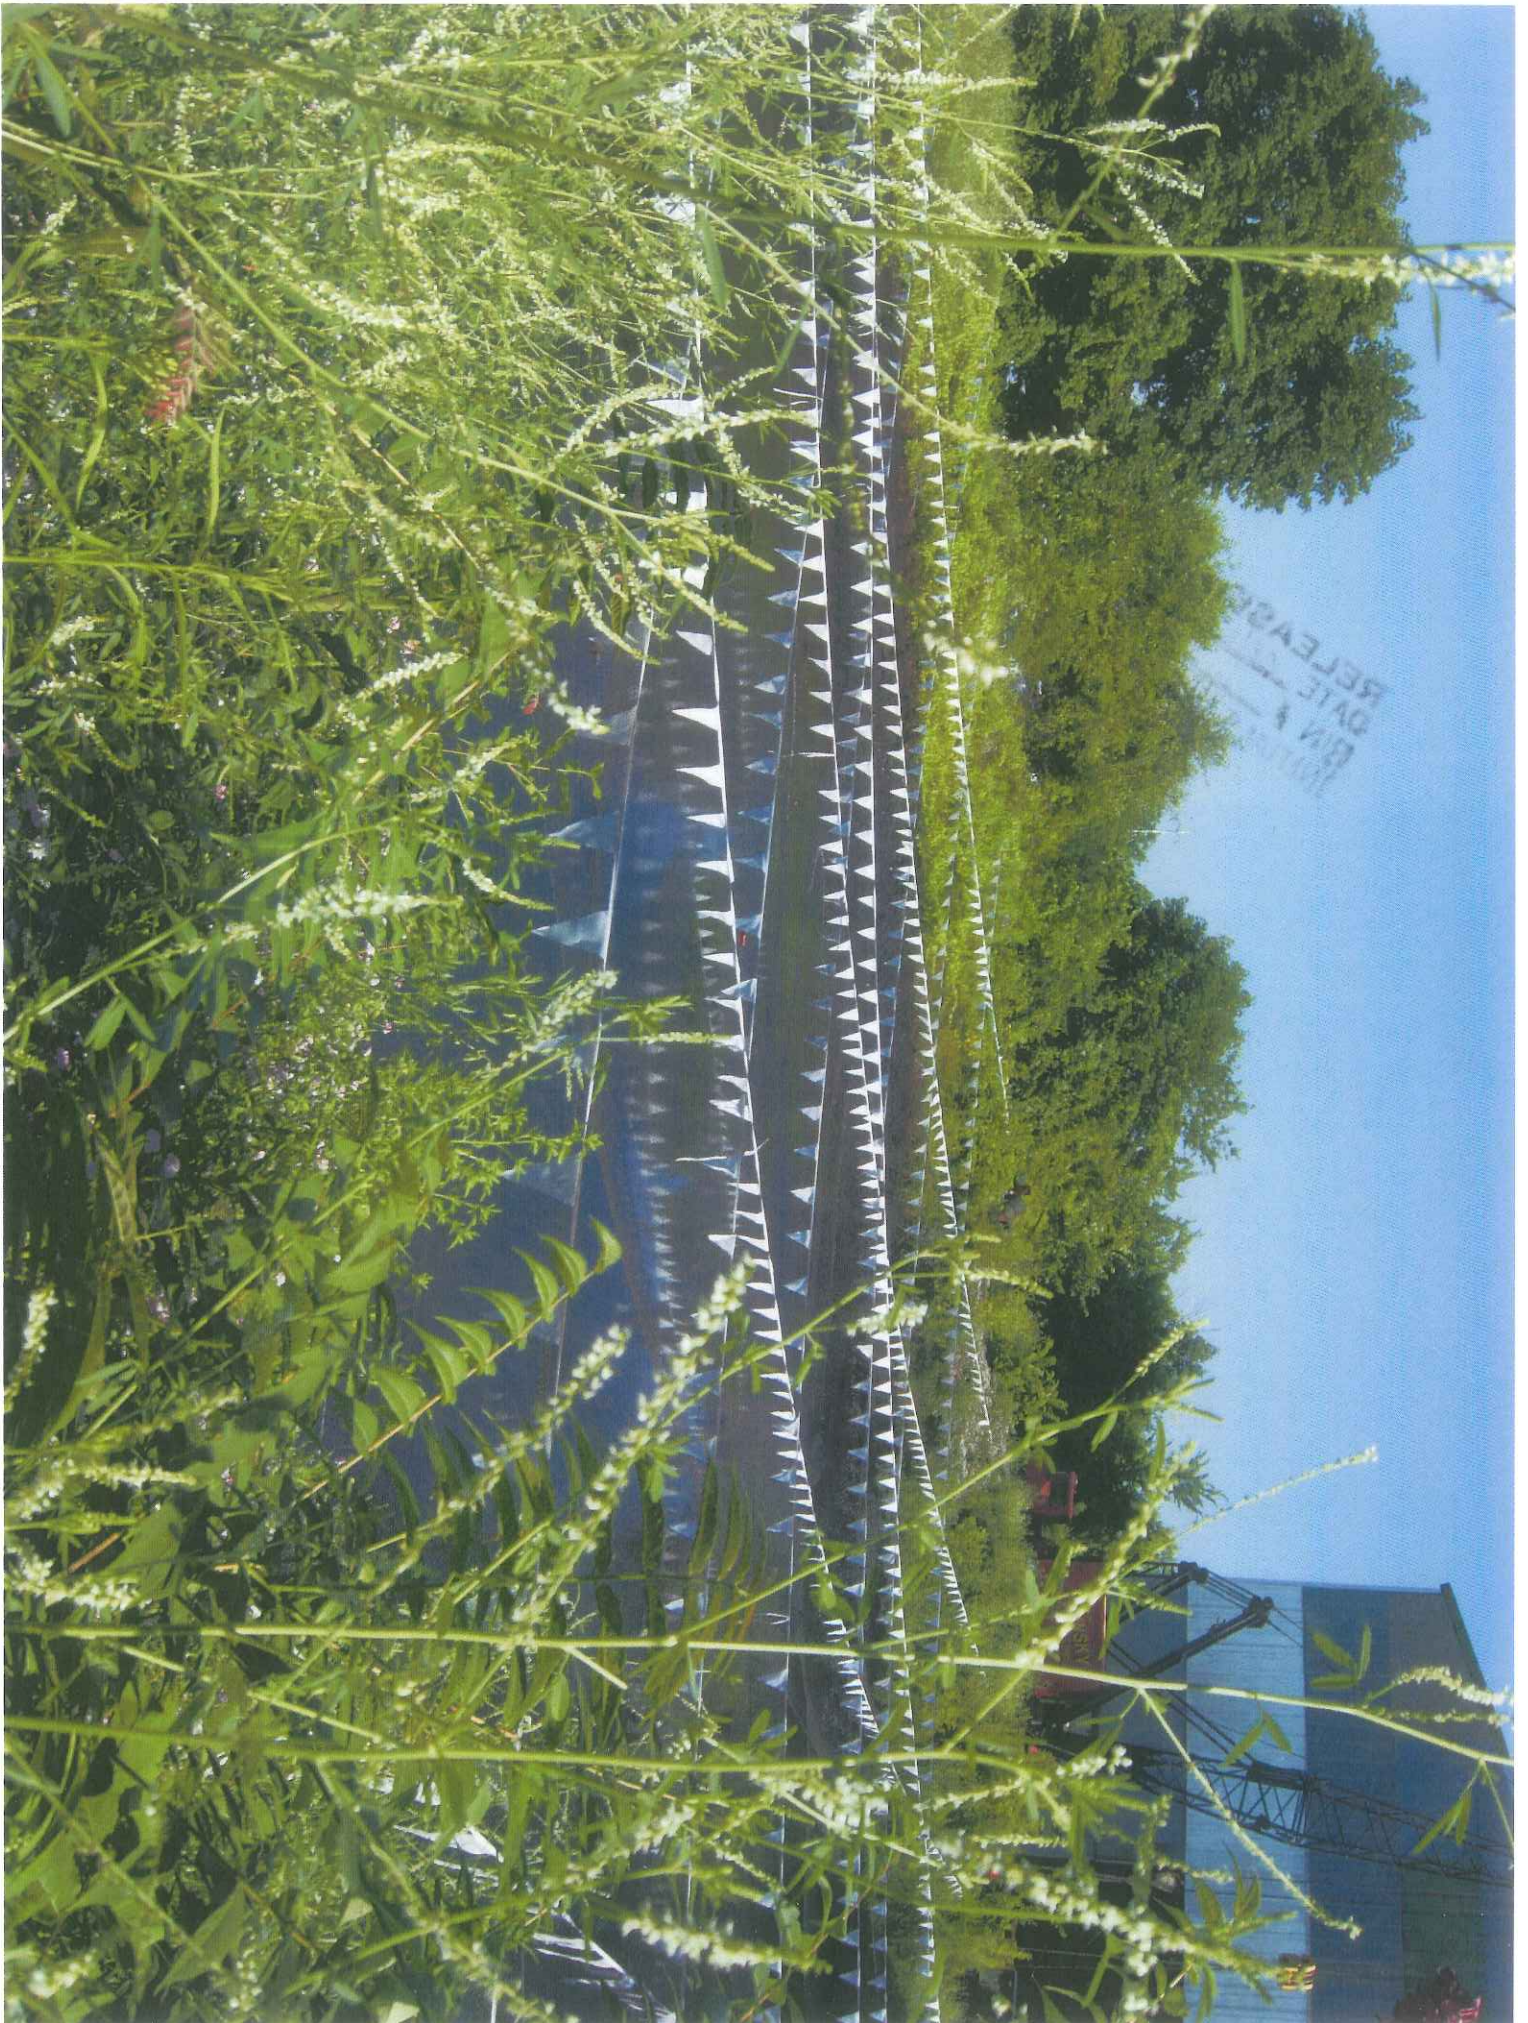
Canton Drop Forge Photo 03, by Mike Beedle, 2011/07/01 07:27:32

| Photo | Description |
|---|--|
| 3 | Pond 1. Facing northwest. Netting can be seen in the oil. |

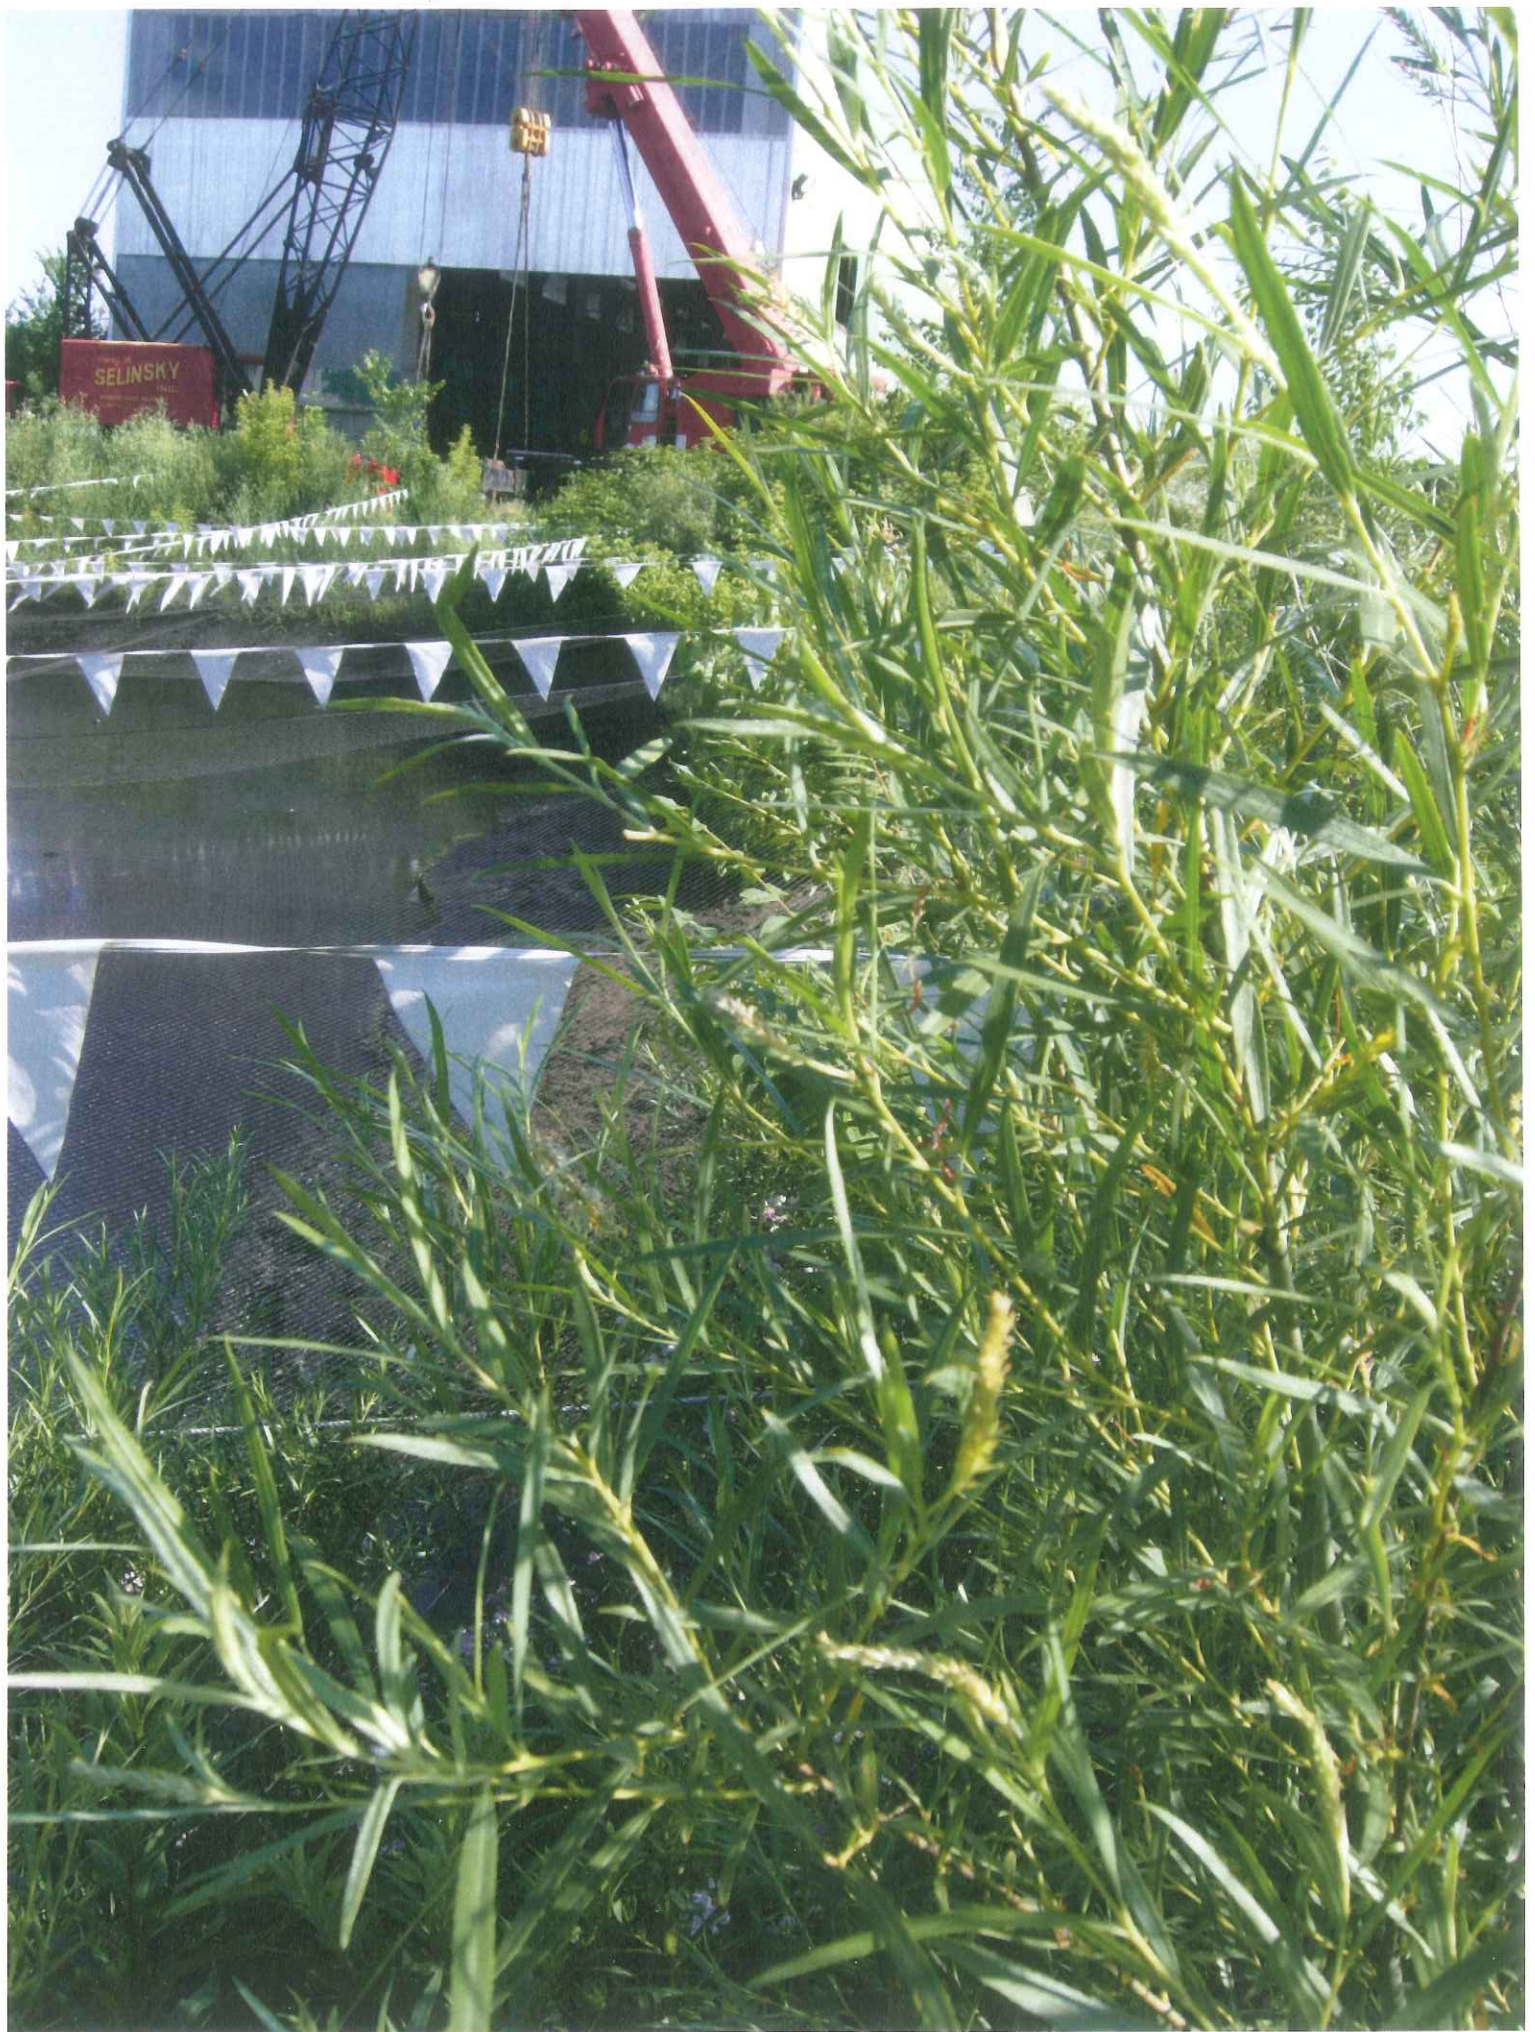
Canton Drop Forge Photo 04, by Mike Beedle ,2011/07/01 07:28:35

| Photo | Description |
|---|--|
| 4 | Pond 1. East bank of pond. |

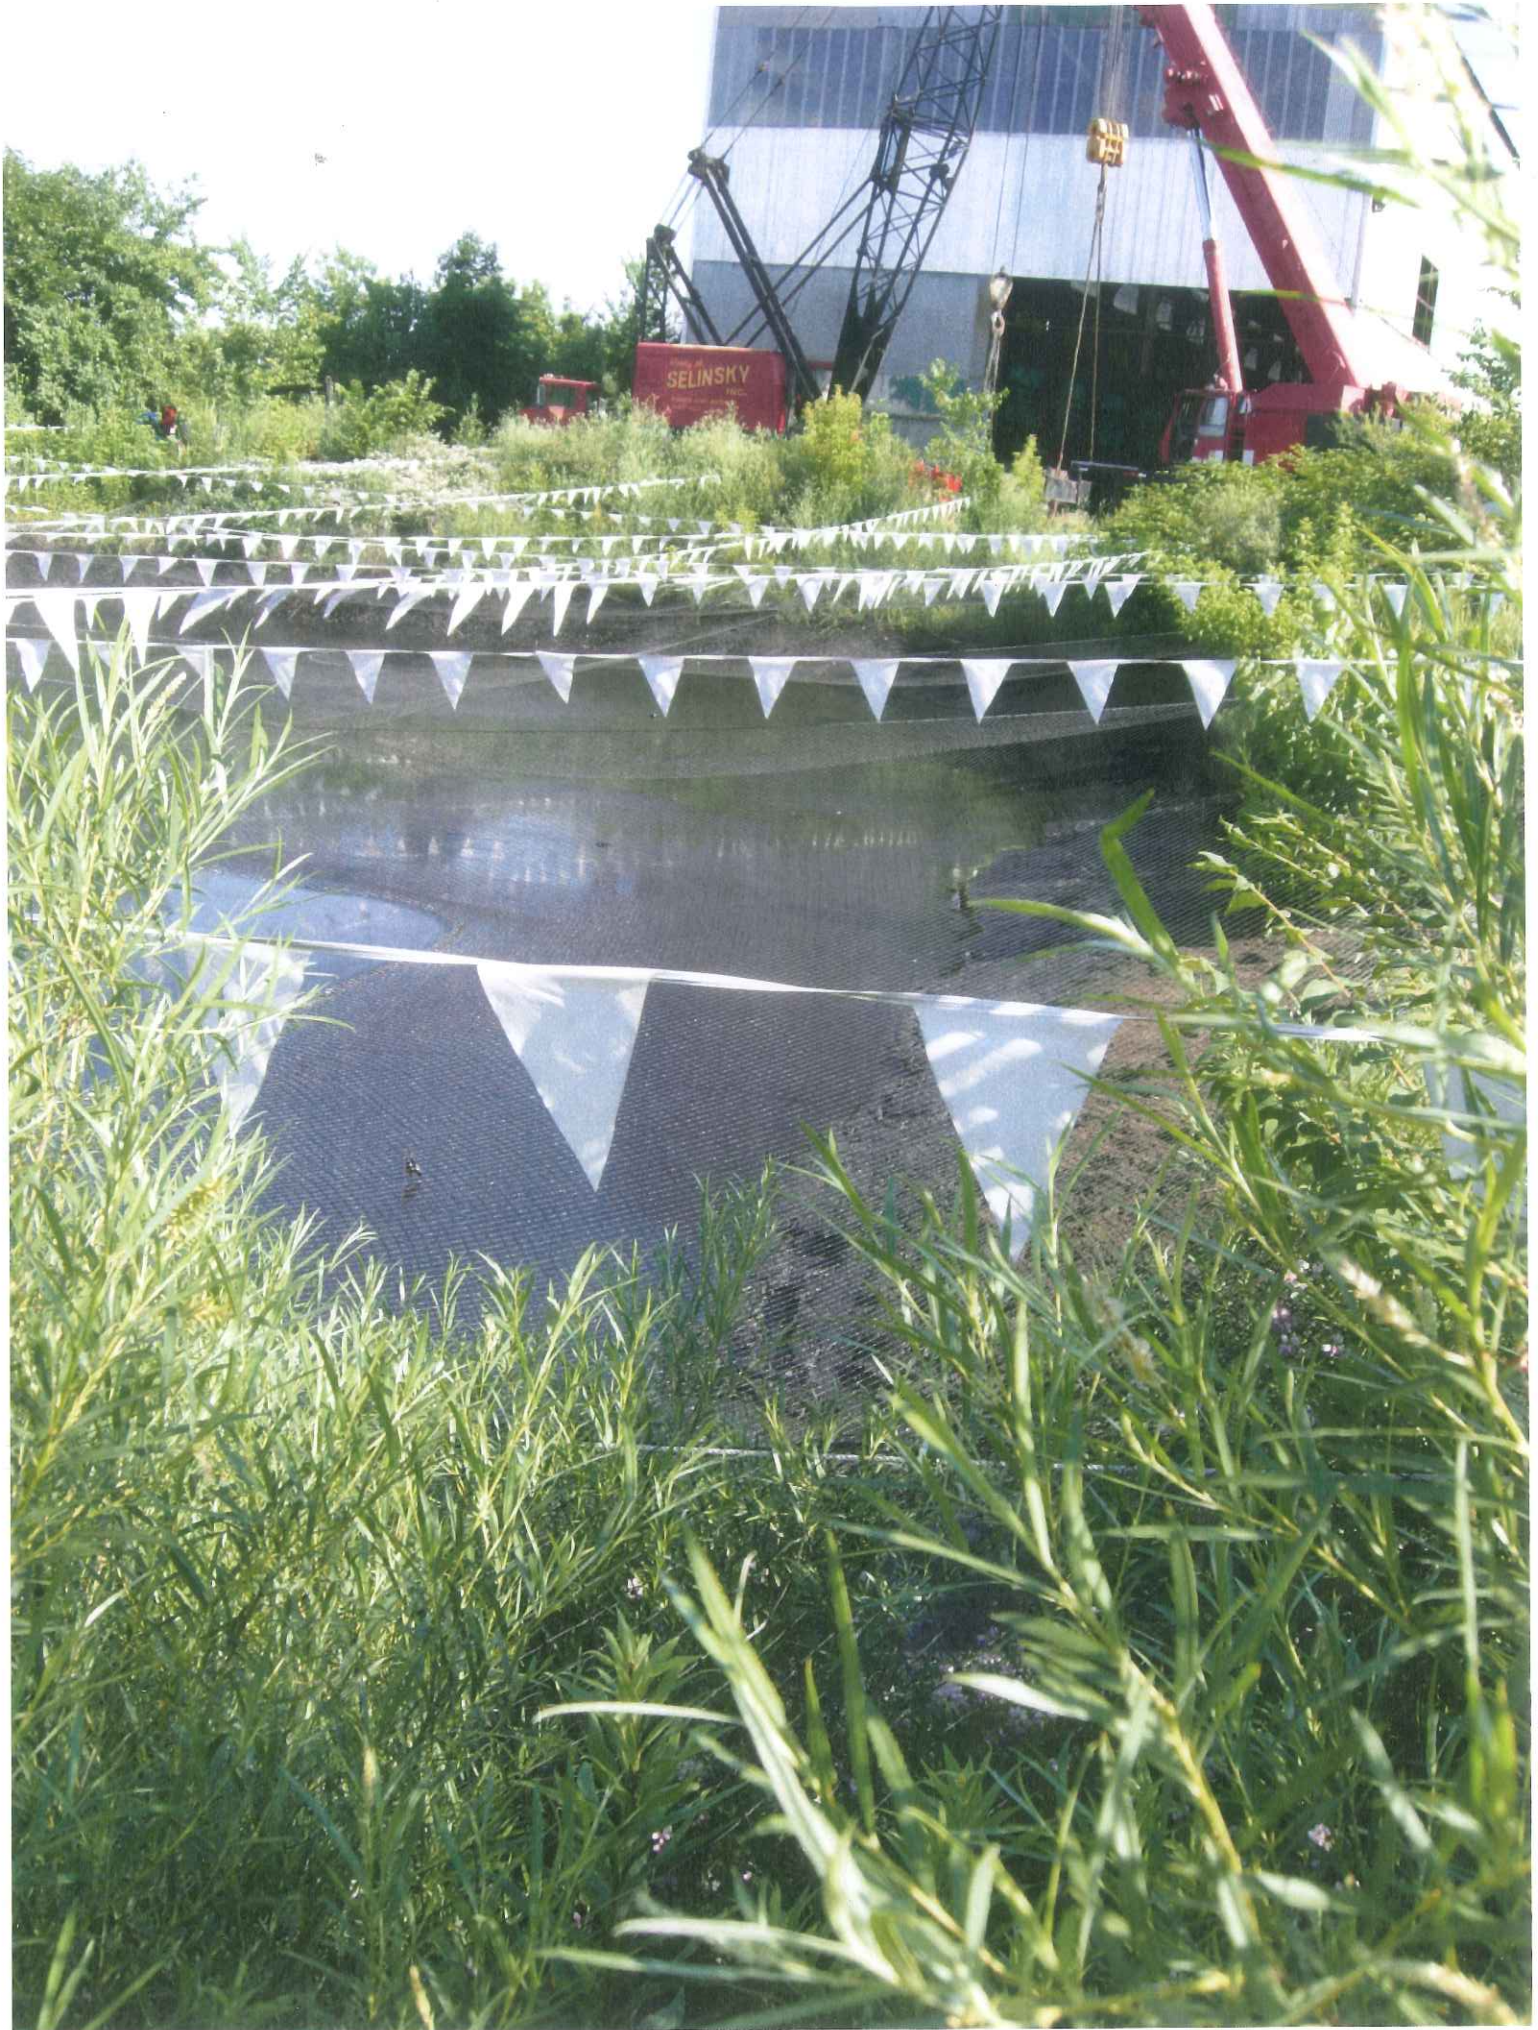
Canton Drop Forge Photo 05, by Mike Beedle ,2011/07/01 07:28:42

I placed a call to Mr. Erryl C. Wolgemuth, Special Agent with the U.S. FWS on July 15, 2011. He said he thought that U.S. FWS had been to the site previously about the time of the report of oiled geese. He said he thought that the Ohio DNR had Canton Drop Forge place the netting and flags on the ponds in response to the oiled geese report. I sent Mr. Wolgemuth photograph 5 in which appeared to be an oiled bird caught in the netting.

| Photo | Description |
|---|--|
| 5 | Pond 1. Facing northwest. Netting can be seen in the oil. |

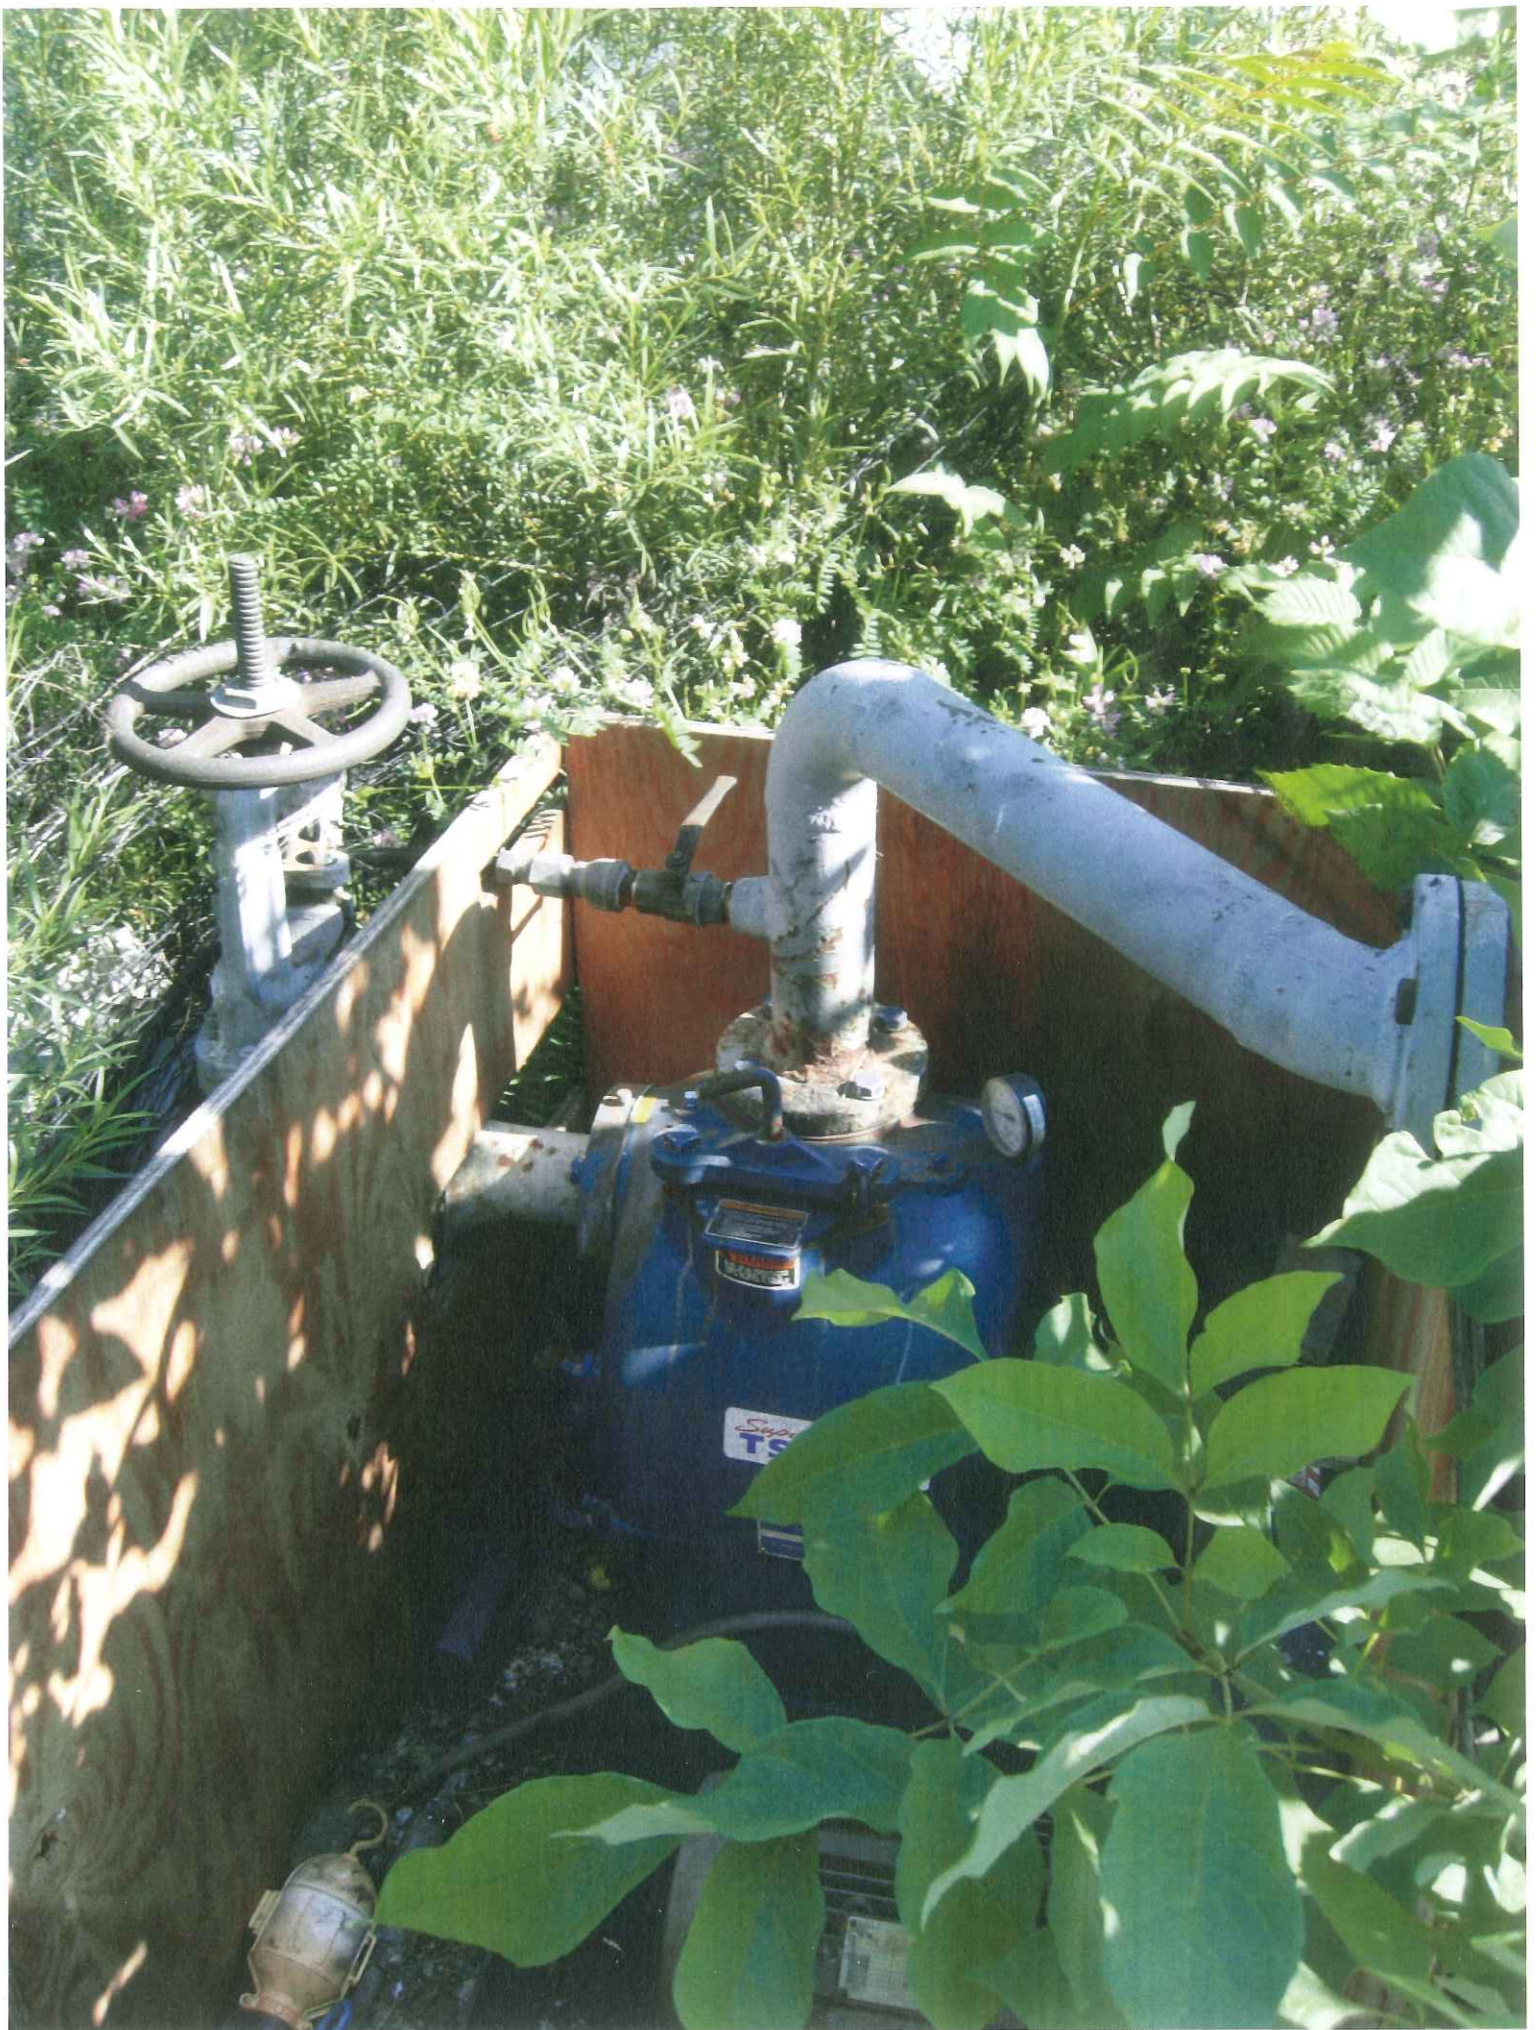
Canton Drop Forge Photo 06, by Mike Beedle ,2011/07/01 07:29:01

| Photo | Description |
|---|--|
| 6 | Pump used to transfer material from Pond 1 to Pond 2. Pump was not running at the time of the inspection. |

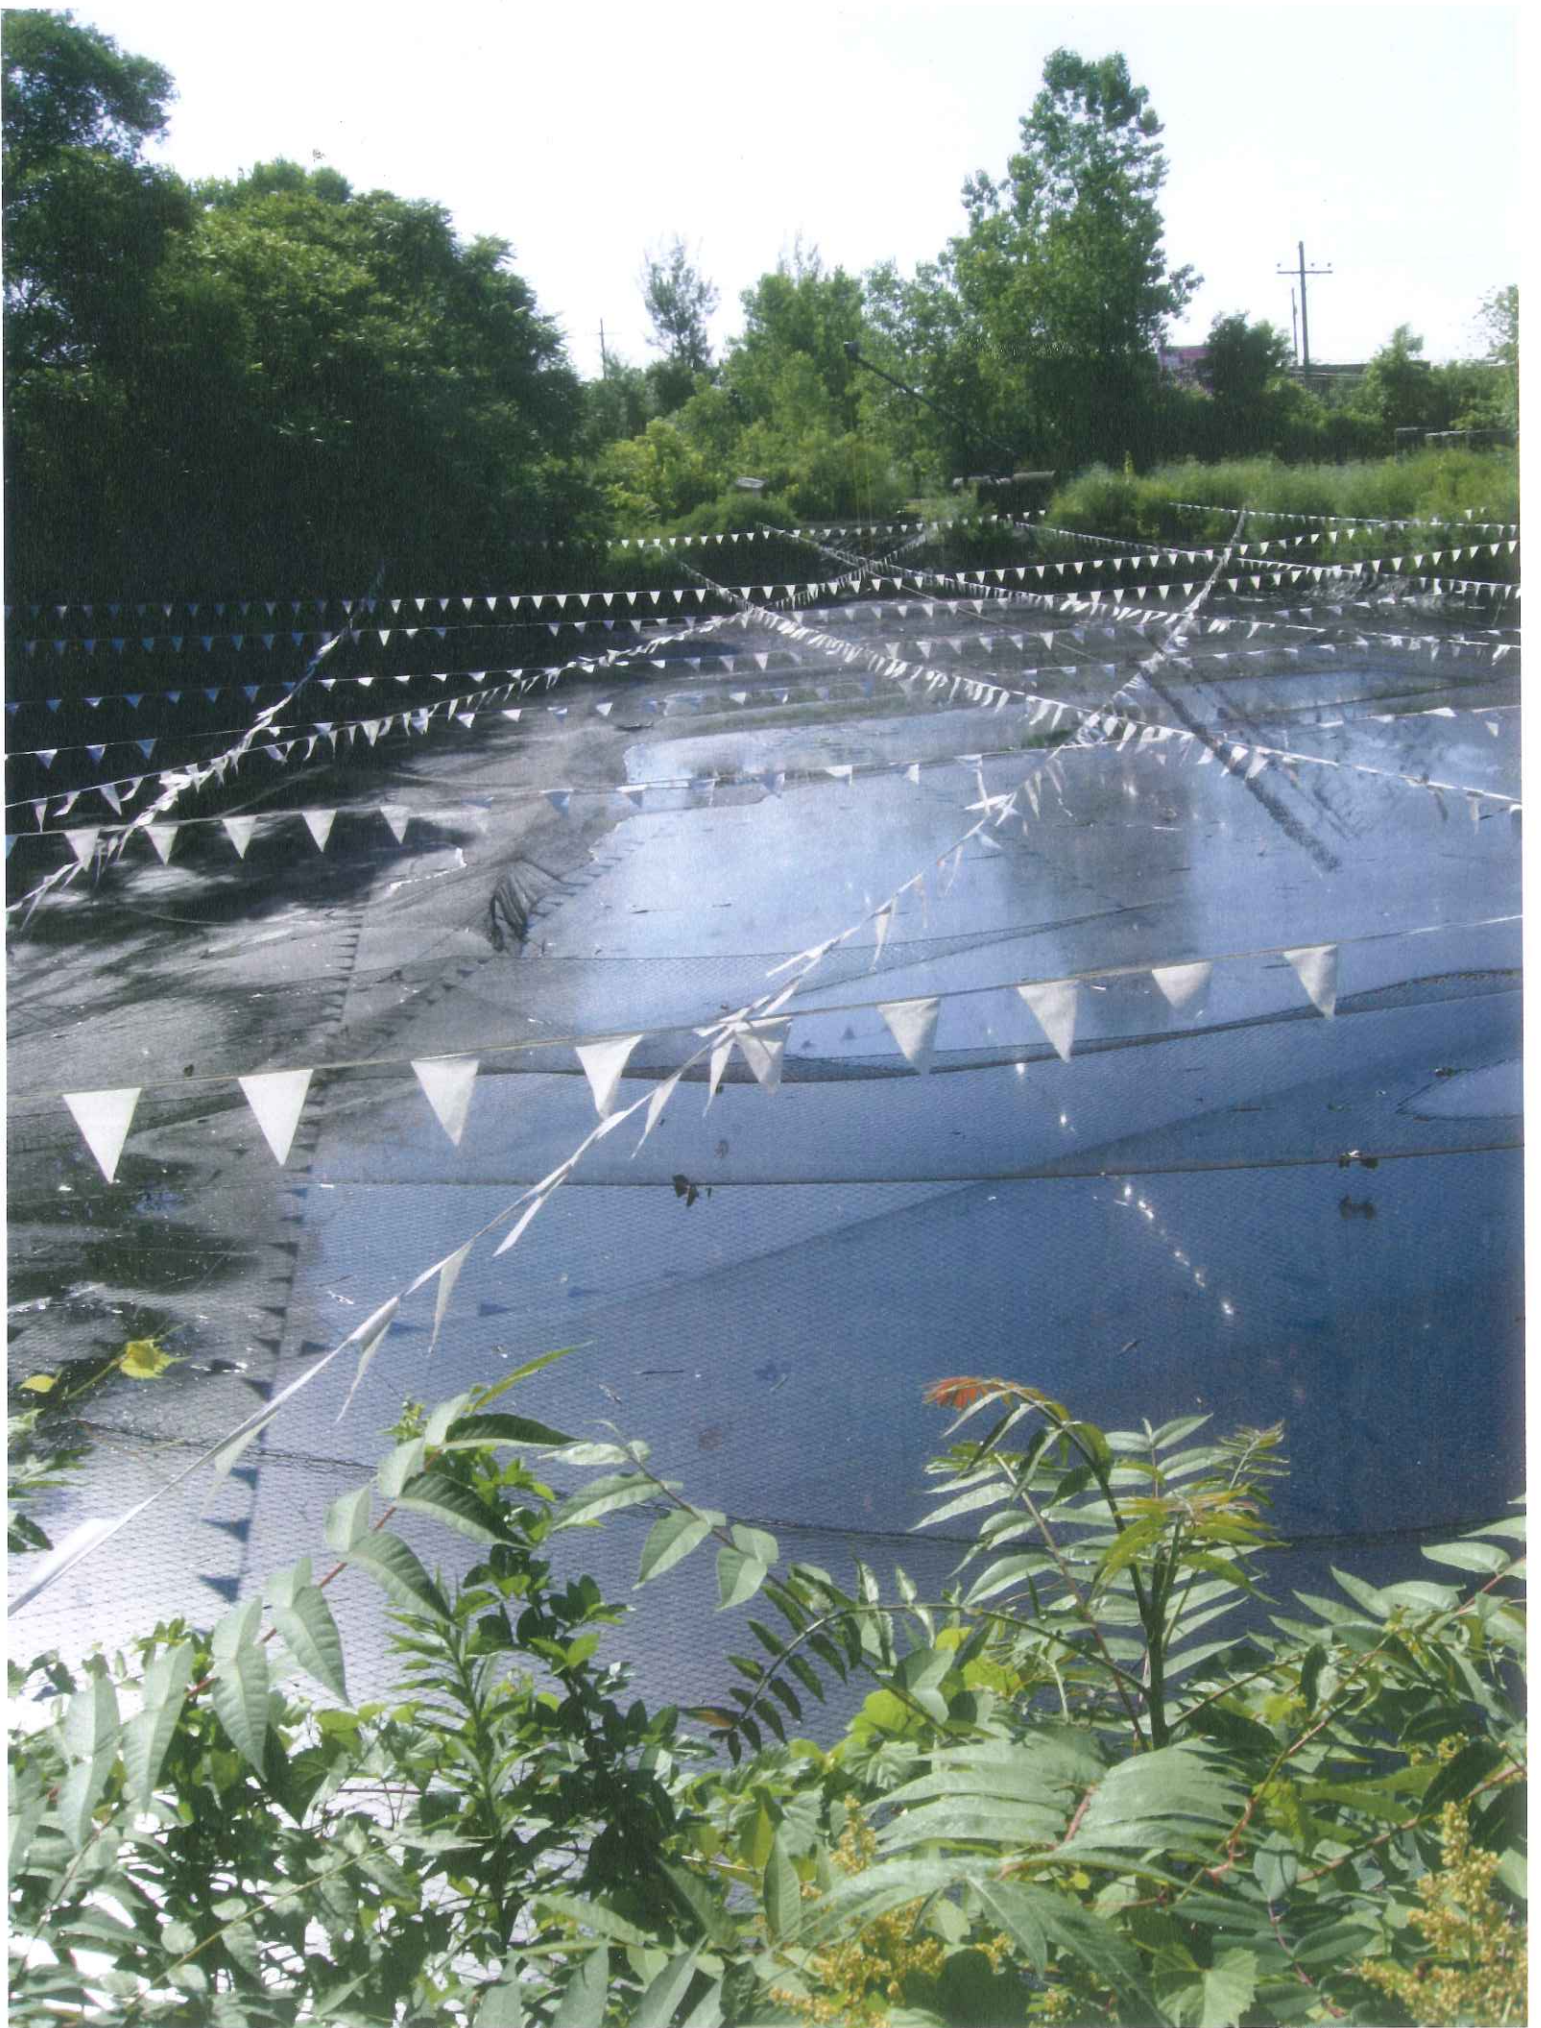
Canton Drop Forge Photo 07, by Mike Beedle, 2011/07/01 07:38:05

I noticed the smell of oil as we arrived at Pond 2. There were flags and netting on the pond. Mr. Houseknect said the netting was placed on the pond last year (fall 2010) and flags this year (spring 2011). See photographs 7-10 and 17-26 of Pond 2. Mr. Houseknect said Pond 2 receives water from Pond 1, drains, down spouts, cooling water and surface water. He said it has more oil than Pond 1 and that is why Canton Drop Forge skims and pumps oil off Pond 2.

| Photo | Description |
|---|--|
| 7 | Pond 2. Near the middle-south side of facility. Oil over the entire surface of the pond. Netting and flags over pond to keep geese from landing. Heavily vegetated area. Taken from the west side of the pond facing east. Netting can be seen in the oil. |
